Case Study

The impact of changes in the geological conditions of road bedrock layers while the road was in use

DOI 10.2478/otmcj-2019-0008

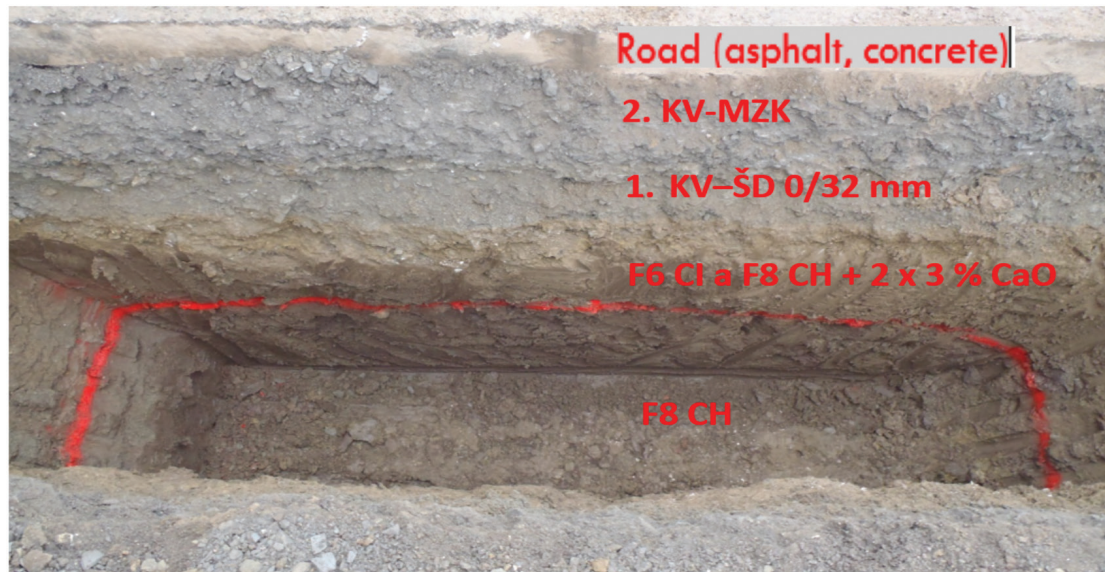
Fig. 3: Profile of the excavated survey probe showing the deformation of the underbase layer.

The surveys revealed two road structural layers beneath the asphalt and asphalt-concrete road surface. These layers were 0.5–0.6 m deep, with the following composition (from top): second structural layer = MZK, first structural layer = ŠD fraction 0–32 mm.

Their base contained a lime-treated ($2 \times 3\%$ CaO) active zone (Figure 3). The bedrock consisted of eolic loess sediments of class F6 CI and eluvial, highly plastic claystone and siltstone with a class FB CH soil character. The depth of the treated soils was approximately 0.5 m. The bedrock of the lime-treated soils included untreated eluvial claystone F8 CH. The probes exposed volcanic Těšín basalts with a class S4 SM soil character.

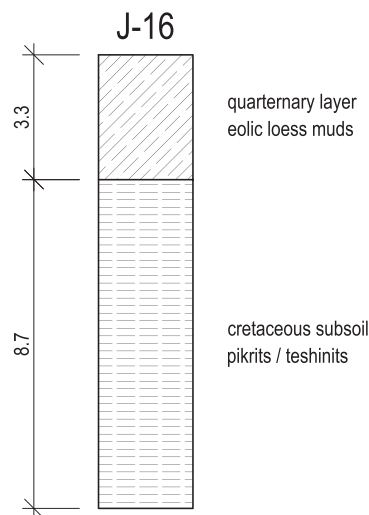
**Fig. 4:** Diagram of a geological borehole at the location of deformations.

Several geological boreholes were excavated along the given road section. The borehole designated J 16 penetrated the road where the deformations occurred when the road had been in use (Figure 4). Fine-granular soils at the construction site were initially treated using burnt lime [calcium oxide (CaO)], which was mixed with the soil using a ground cutter.

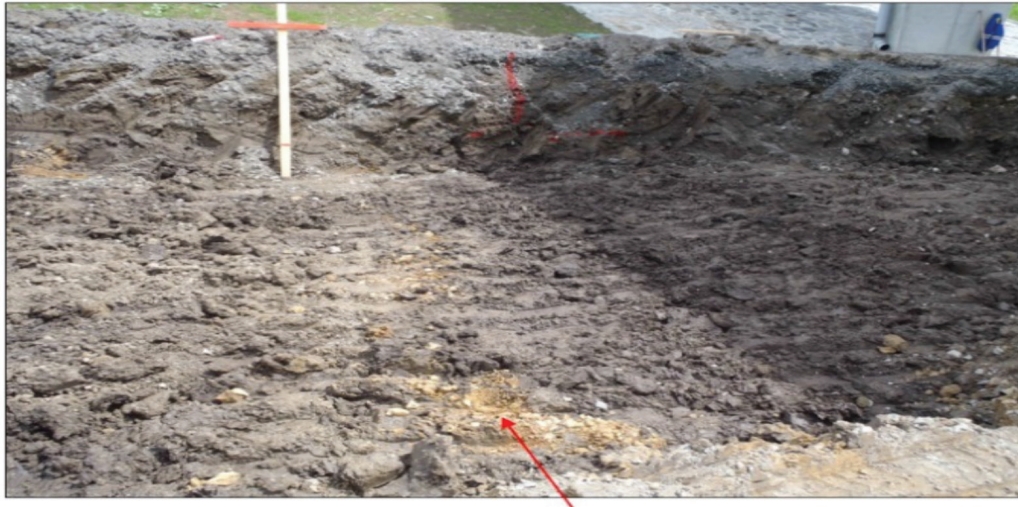
Fig. 5: Location of highly permeable rocks in the contact aureole in the active zone's bedrock.

The macroscopic assessment of the surface of the excavated bedrock identified significant inhomogeneity with permeating groundwater, due to which areas of eluvial clays (approximately 90–95% of the excavated soil) alternated with areas of highly permeable rock (Figures 5 and 6). The locally moist rocks were part of a contact aureole (Těšín

sediments) with a shelf of marlite and limestone in the layer of eroded claystone. These rocks were not discovered by any of the survey probes, which is why their presence at the reconstructed section was unexpected. As moisture content increased, i.e. $w_n > 20\%$, which was very probable according to the conditions identified after removing the structural layers and active zone, the mechanical and physical characteristics of the treated bedrock could be changed. For this reason, the proposed reconstruction process was modified according to the proposal included in the reconstruction method modifications.

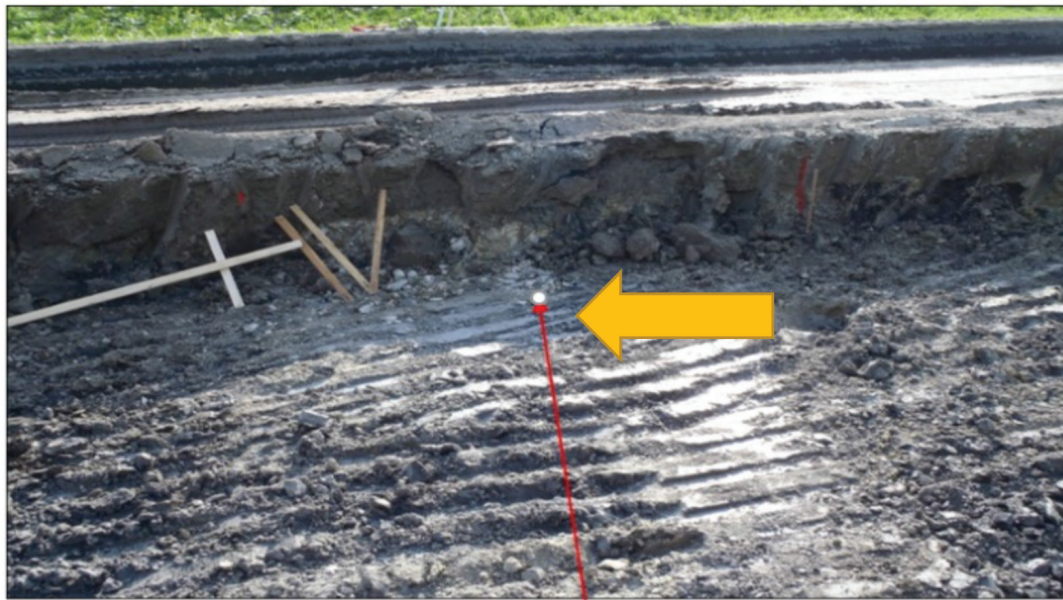
Fig. 6: Location of highly permeable rocks (limestone) in the active zone's bedrock.

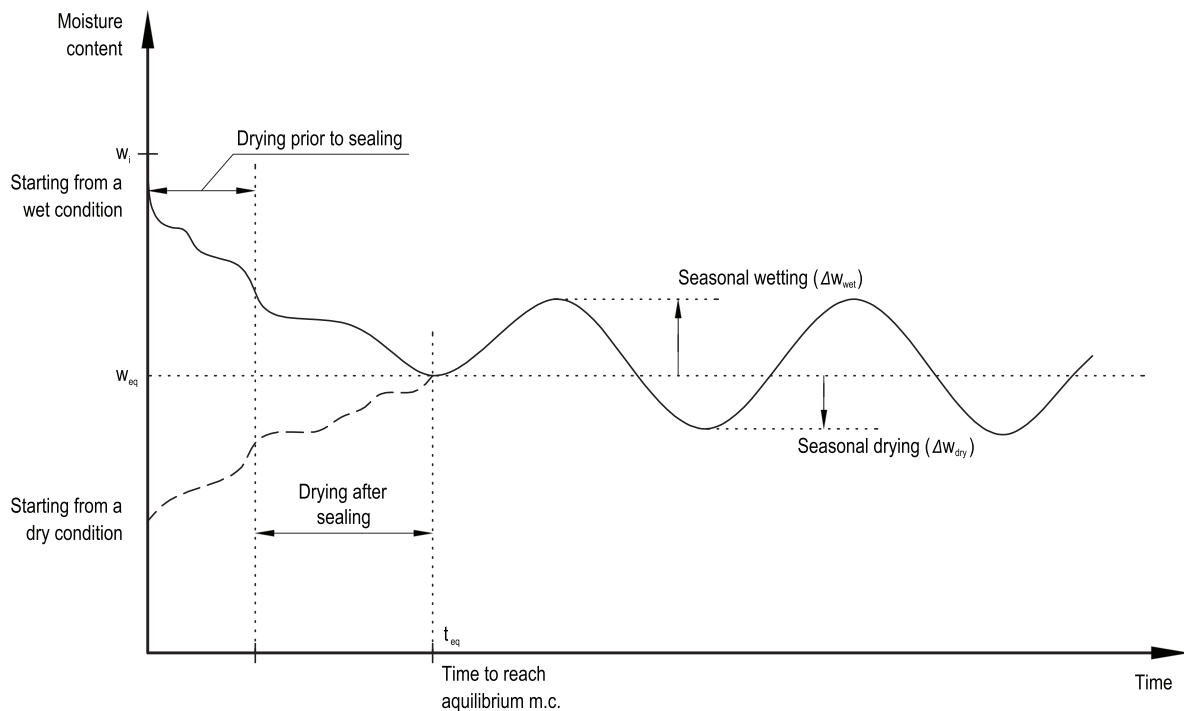
Fig. 7: Moisture content as work is conducted.
